# Manhole Inspection Summary

Manhole # **S19A\_\_027MH**

Insp Date: **10/24/07 11:09 AM**

**Location** Address: **2001 LANVALE-RAYNOR**

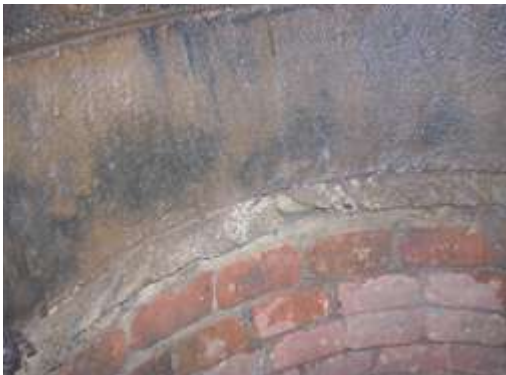
Defect 3

Condition: ☐ Sound ☐ Cracked ☐ Root Intrusion ☐ Loose Brick ☒ **Deteriorated**

DETERIORATED CHIMNEY

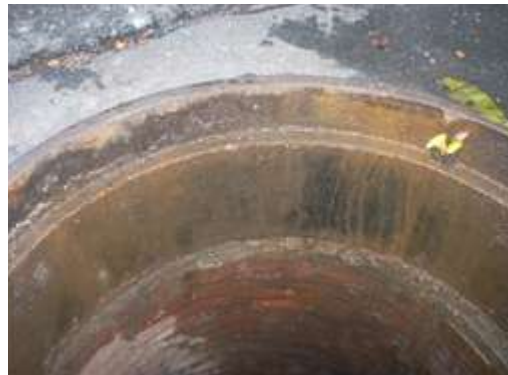
Defect 2

Infiltration: ☐ None ☒ **Joint** ☐ Cracks ☐ Mortar ☐ Roots ☐ Wall

INFILTRATION OF THE JOINT

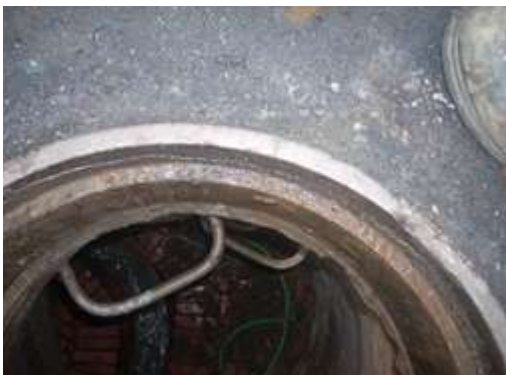
Defect 1

Offset: **0.5** (in.)

FRAME OFFSET

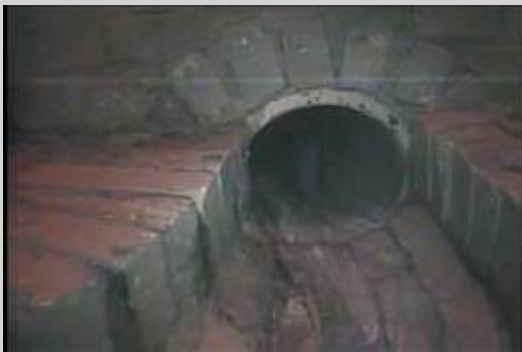
12 O'Clock Outflow

8 in. Circular Gravity Sewer  
Pipe Out @ 12 O'Clock

Pipe Height: **7.2** (in.) Rod and Bar (Angled)  
Pipe Material: **Clay** ☐ Pipe Lined  
Invert Depth: **8.40** (ft.) Flow Characteristics: **Fast**  
Deposits: ☒ None ☐ Mud ☐ Sludge ☐ Debris ☐ Grease  
Silt Depth: (in.) Deposits Extent:  
Infiltration: **None** Pipe Seal Cond: **Sound**
